U.S. Chemical Safety and Hazard Investigation Board

## Safety Bulletin

# Key Lessons from the ExxonMobil Baton Rouge Refinery Isobutane Release and Fire

No. 2016-02-I-LA

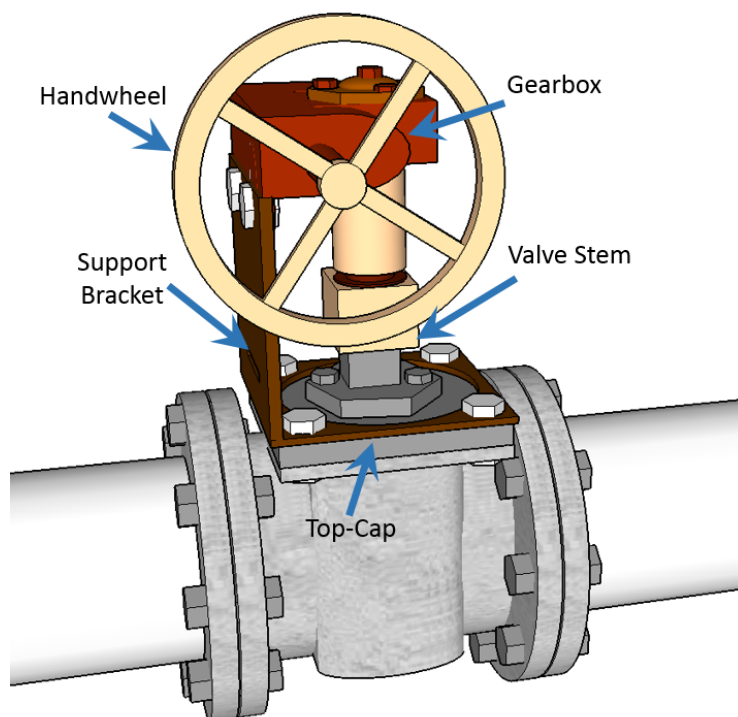
Infrequently used plug valves like this one are often operated manually. An operator turns a handwheel connected to a gearbox to open or close the valve.<sup>8</sup> (Figure 2). The handwheel rotates gears to turn the valve stem into the open or closed position, and a support bracket attaches the gearbox to the valve body using bolts. On the afternoon of the incident, one of the operators attempted to open the plug valve to the spare pump using the handwheel attached to the valve. But the gearbox was not operating properly, and although the handwheel turned, the valve did not open.<sup>9</sup>

Figure 2. Illustration showing an alkyl unit plug valve with gearbox, valve stem, top-cap, support bracket, and handwheel similar to the one involved in the incident.

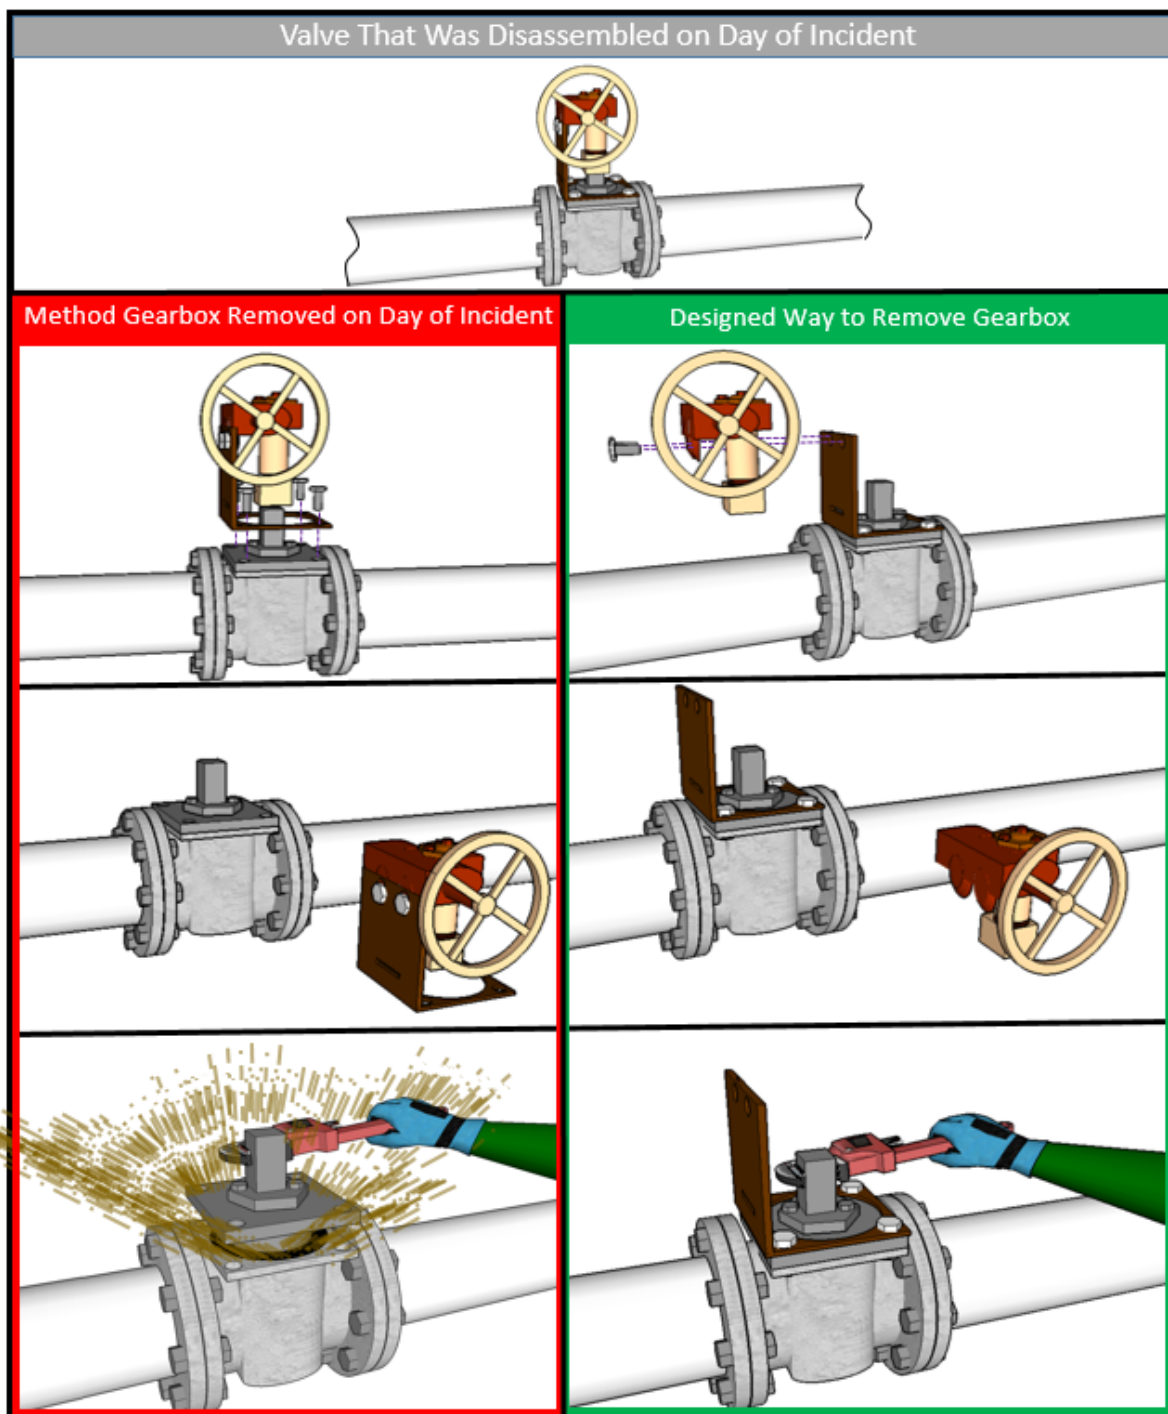
One of the operators removed the gearbox assembly so he could turn the valve stem with a pipe wrench to open the valve.<sup>10</sup> Removing a malfunctioning gearbox from a plug valve is an accepted practice for alkyl unit operators.<sup>11</sup> To remove the gearbox, the operator removed the four vertical bolts that connected the gearbox support bracket to the valve body.<sup>12</sup> These four bolts, however, also secured the top-cap – a pressure-retaining component – to the valve body.<sup>13</sup> The two horizontal bolts that could safely remove the gearbox from the support bracket remained in place. (Figure 3).

One of the operators then opened the valve by rotating the valve stem with a pipe wrench, while the other operator observed. With the four bolts removed from the top-cap, critical valve components were no longer held together. When the operator turned the valve stem, the plug valve loosened and came apart. Pressurized isobutane<sup>14</sup> escaped from the valve body, forming a flammable white vapor cloud.

Figure 3. Gearbox removal. The left column illustrates how operators removed the plug valve gearbox on the day of the incident. It shows operators removed the entire support bracket. By design, removing the gearbox did not require removing the four vertical bolts that secured the pressure-retaining top-cap. The right column illustrates how the plug valve gearbox should be disassembled. The gearbox and handwheel could be disconnected from the support bracket by removing the two horizontal bolts on the side of the support bracket.

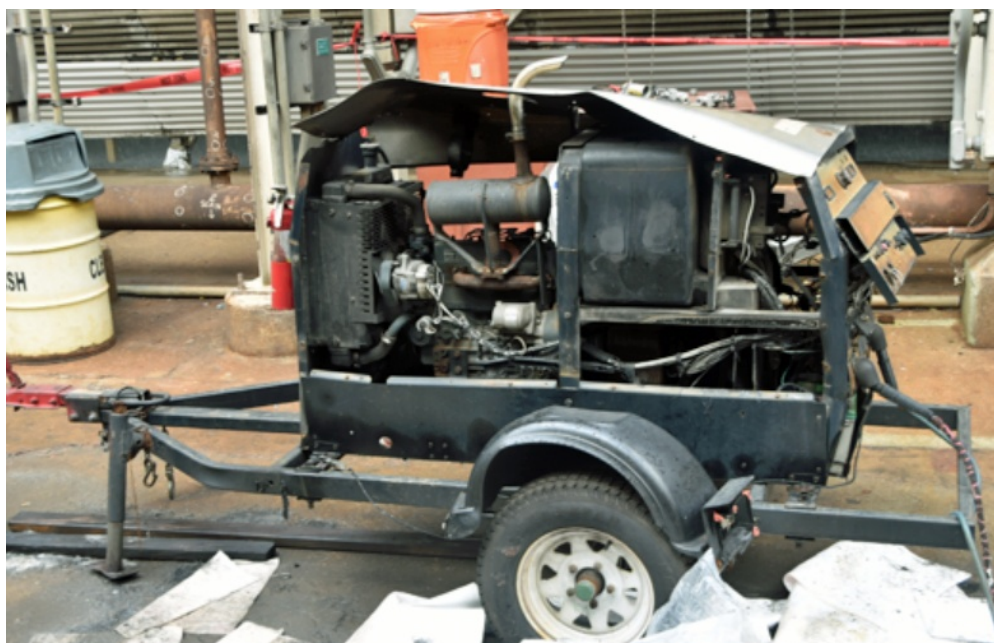
ExxonMobil estimated that 2,000 pounds of isobutane released into the atmosphere. Based on surveillance video, an energized welding machine located roughly 70 feet away likely ignited the vapor cloud. (Figure 4 and Figure 5). The resulting fire seriously injured one ExxonMobil employee and three contractors working in the vicinity of the release.<sup>15</sup> Emergency responders isolated the release and extinguished the fire about 25 minutes after the initial ignition.

Figure 4. Welding machine that was the likely ignition source of the isobutane vapor cloud.

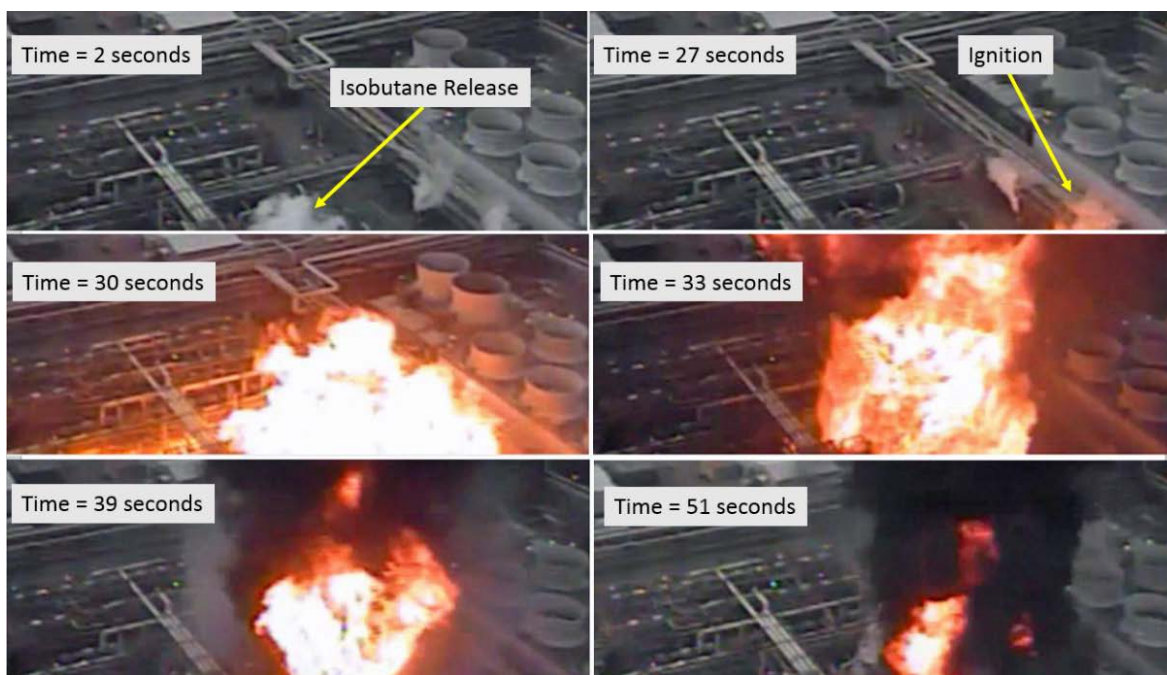
Figure 5. Sequence of events. Baton Rouge refinery security video clips showing the isobutane release and subsequent fire. This sequence does not show time zero – the first indication of the isobutane vapor cloud.

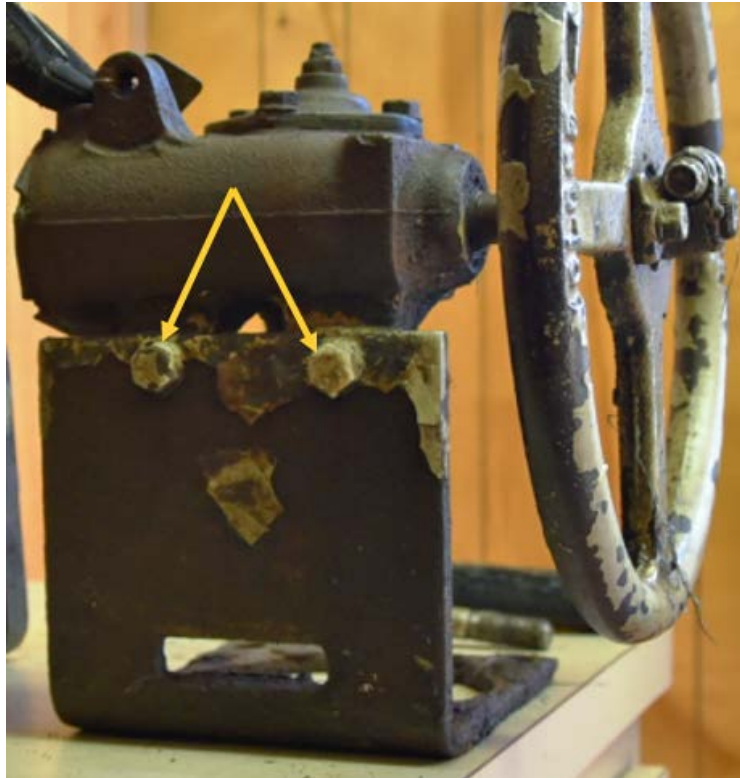
The gearbox involved in the incident conformed to this part of the standard because it *could* be removed without removing any pressure-retaining parts. The operator could have removed the two horizontal bolts that connect the support bracket directly to the gearbox, rather than the four vertical bolts that secure the support bracket to the pressure-retaining top-cap (as shown on the right side of Figure 3 and in Figure 6). But the operator did not remove these two horizontal bolts; instead, he removed the four vertical bolts, which he believed to be the correct bolts to remove.

Figure 6. Gearbox support bracket for the valve involved in the incident. The two horizontal bolts (yellow arrows) can be removed to take the gearbox off the support bracket and the valve without disturbing the top-cap bolts. By removing the gearbox in this manner, the pressure-retaining valve components are not disturbed.

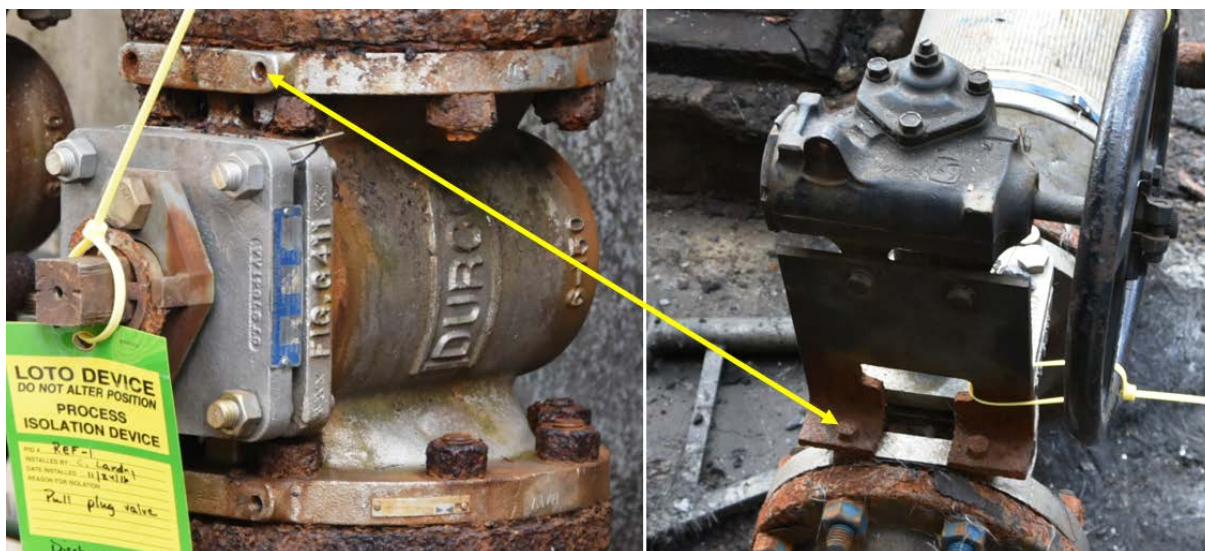
The CSB learned that the plug valve manufacturer (Durco) updated the plug valve design in 1984 so that the gearbox support bracket could be attached to the valve using different bolt connections than those that secure the pressure-retaining top-cap to the valve body. Approximately 97 percent of the plug valves located in the Baton Rouge refinery's alkylation unit are the more recent Durco plug valve design, which secures the gearbox assembly to the valve body flanges. (Figure 7 and Figure 8). With this improved design, the gearbox support bracket is unlikely to connect to the pressure-retaining top-cap, which can help prevent future incidents.

Figure 7. The improved plug valve design includes an additional four gearbox support bracket holes separate from the pressure-retaining top-cap (located on the valve body flanges) as seen at the yellow arrows. The photo on the right shows a gearbox support bracket attached to the valve body flange for a valve that was not involved in the incident. The photo on the left shows a different plug valve in the alkylation unit with its gearbox removed.

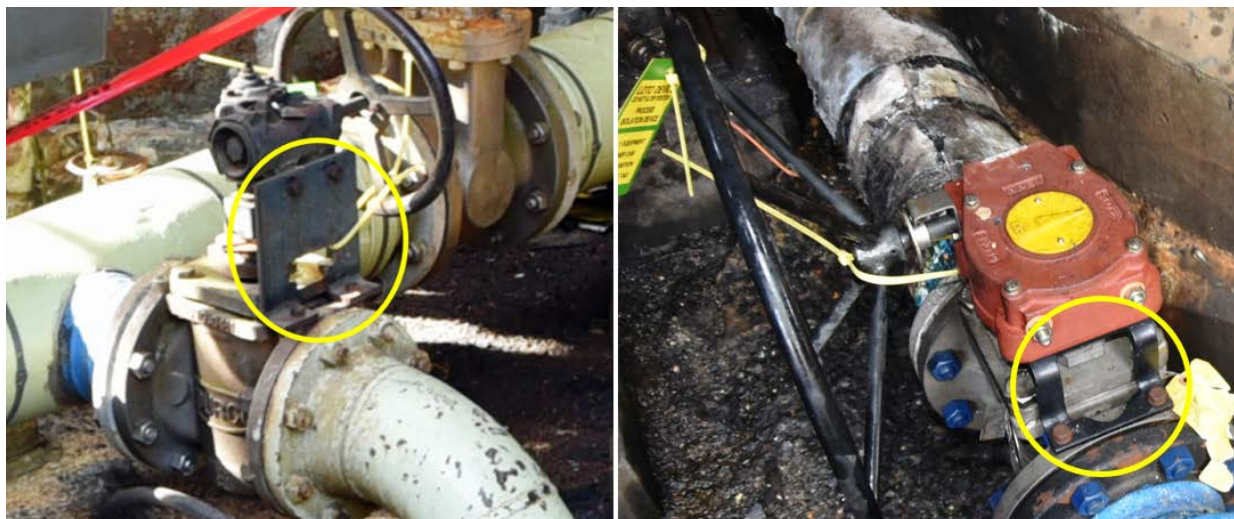
Figure 8. Two of several designs of gearbox support brackets (yellow circles) used at the Baton Rouge refinery. These specific brackets attach to the valve body flange – they are not among the approximately three percent of valves in the alkylation unit that attach the gearbox support bracket using the same four vertical bolts that secure the pressure-retaining top-cap.

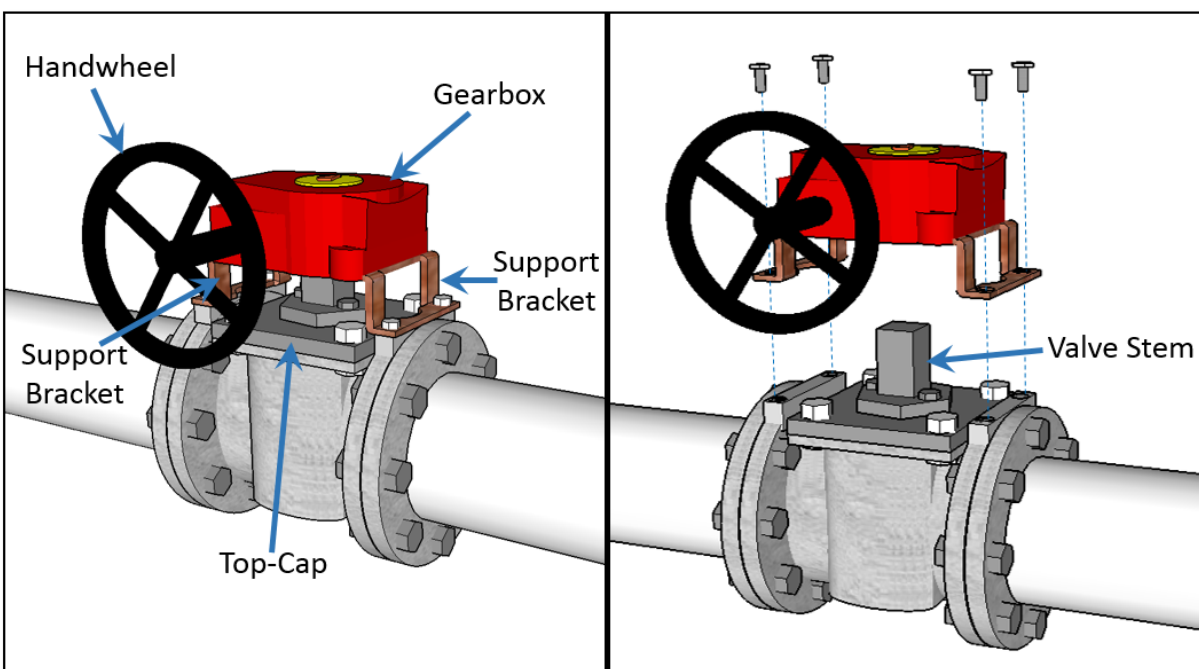
The newer plug valve more broadly used in the alkylation unit is a better design. The redesign addressed the potential to have a chemical release when removing the gearbox assembly. The valve designers provided four additional connection points to secure the gearbox support brackets and these attachment locations are not pressure-retaining components. (Figure 9). With the newer and improved valve design, if a worker completely removes the gearbox and its support bracket(s), a chemical release cannot occur.

Figure 9. The post-1984 plug valve design, showing how one type of gearbox connects to all four dedicated attachment points on the valve flanges that are not pressure-retaining parts.

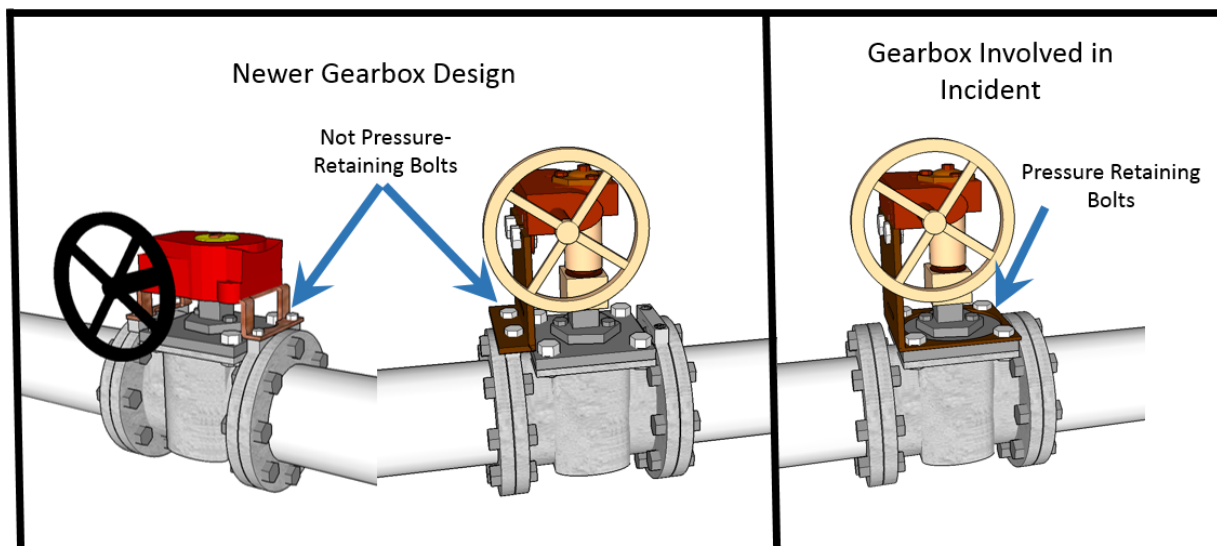
The location of the bolts on the newer valve design may have also contributed to the operator removing pressure-retaining bolts. On the newer design, the bolts connecting the support bracket to the valve are vertical, and are usually removed in order to remove the gearbox and handwheel. In describing how to remove a gearbox from this type of plug valve, an alkylation unit operator explained, “I would only have to pull those [vertical] bolts right there and the whole thing would come off.” Although another operator recognized that there were two different ways to remove the plug valve gearbox, there was not a preferred method. While looking at a photo of a plug valve to explain how to remove the gearbox, the operator said either the horizontal or the vertical bolts could be removed.

For the less common, older valve design, the vertical bolts were the pressure-retaining bolts and should not be removed; instead, the horizontal bolts should be removed to disassemble the gearbox and handwheel safely. (Figure 9 and Figure 10). It could appear as though these critical vertical bolts had to be removed to take the inoperable gearbox off the valve. Although other bolts allowed for gearbox removal without touching the critical pressure-retaining bolts, this design can lead to potentially

catastrophic consequences. The CSB concludes that poor equipment design was a significant factor that led to this incident.

Figure 10. Comparison of newer gearbox attachment designs, which are among the approximately 97 percent of the gearboxes in the alkylation unit, and the gearbox involved in the incident. Importantly, the improved valve design connects the gearbox support bracket to dedicated connection points on the valve flange as shown in the left illustration.

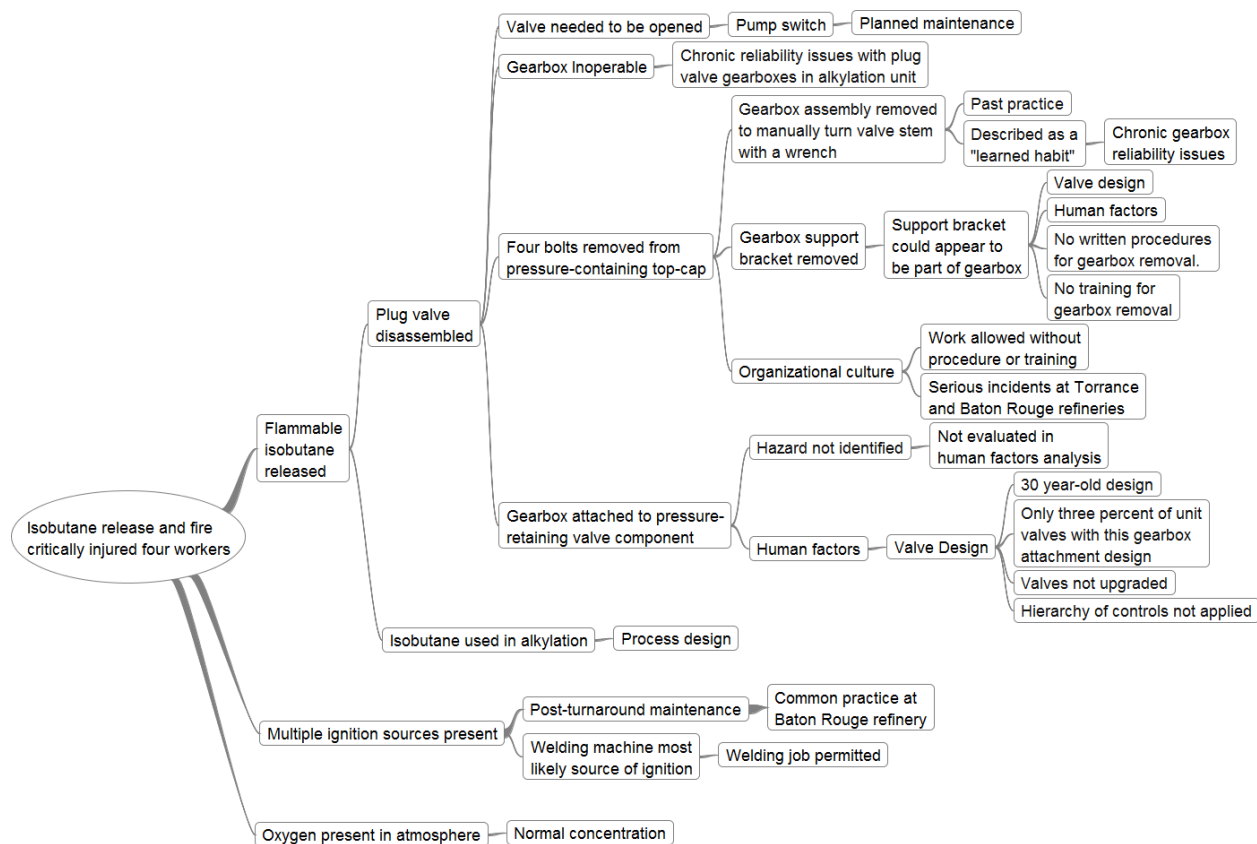
Figure 12. Simplified causal analysis of the November 22, 2016 incident at the Baton Rouge refinery.
