U.S. Chemical Safety and Hazard Investigation Board

## Safety Bulletin

# Key Lessons from the ExxonMobil Baton Rouge Refinery Isobutane Release and Fire

No. 2016-02-I-LA

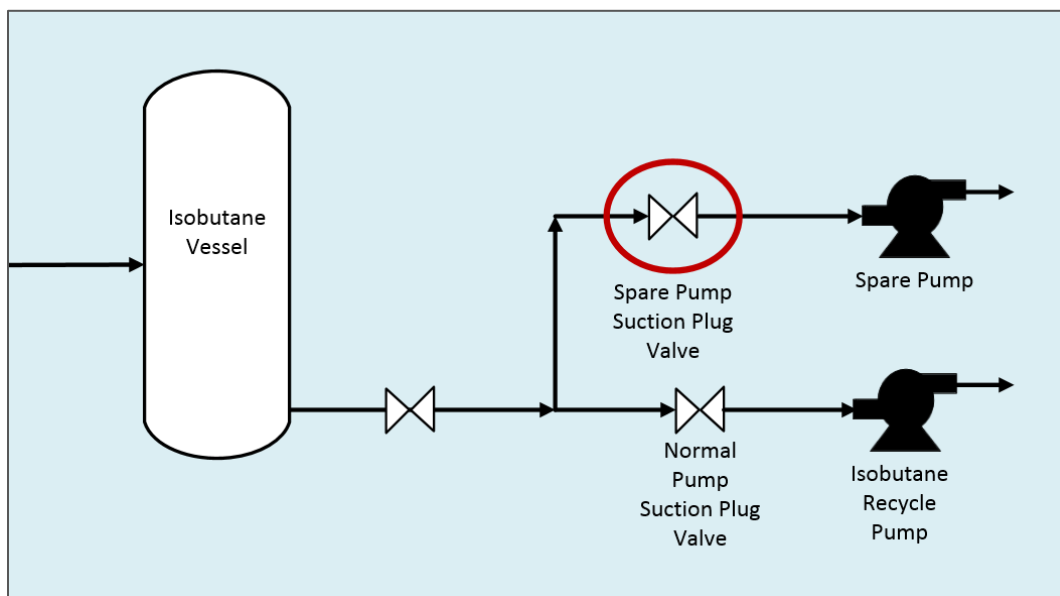
On the afternoon of November 22, 2016, two Baton Rouge refinery alkylation unit operators were preparing isobutane equipment for maintenance.<sup>6</sup> As part of this preparation, the operators needed to adjust valves to put a spare isobutane pump into service. (Figure 1). To switch the pumps, the operators needed to open the inlet (suction) plug valve to the spare pump. The refinery used a type of valve known as a quarter-turn plug valve for many applications in the alkylation unit, including the inlet valves to these isobutane pumps.<sup>7</sup>

Figure 1. Simplified diagram of the alkylation unit equipment where the release occurred.
